## THE IMPACT OF THE GAS TURBINE BLADE HEATING TEMPERATURE IN THE PRESENCE OF AVIATION KEROSENE ON COATING AND ALLOY MICROSTRUCTURE

**Abstract:** Under operating conditions, gas turbine blades may experience overheating. The degree of unfavourable modifications of the condition of both the protective insulating coating and the alloy (microstructure degradation) depends, among other factors, on the temperature and its exposure time. In this study, under laboratory conditions, in the presence of aviation kerosene exhaust gases, the influence of temperature (mainly outside the range of nominal operating temperatures) on the condition of uncooled polycrystalline rotor blades of aircraft turbine jet engines was examined. The object of the research were new gas turbine blades of the SO-3 aircraft engine made of the EI-867 WD alloy, which were exposed to high temperatures for a period of two hours in a laboratory furnace in the temperature range  $T = 1123 - 1523\text{K}$ , every 100K. The article determines the nature of changes (modifications) both in the state of the coatings and in the core material (alloy). A multifactor analysis was taken into account, including in the case of coat

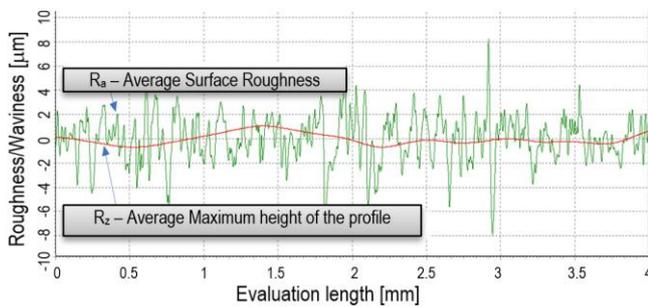
Fig 2. Sample roughness and undulation profile – new blade

A sample roughness profile measured on the ridge in the middle part of a new blade profile is shown in Fig. 2. Based on the obtained measurement data presented in the form of graphs (Figs. 3 and 4), the authors concluded that heating temperature increase entails a decrease in  $R_a$  and  $R_z$  roughness first for a temperature of 1223 K and 1323 K, followed by a clear increase of said parameters at a temperature of 1523 K.

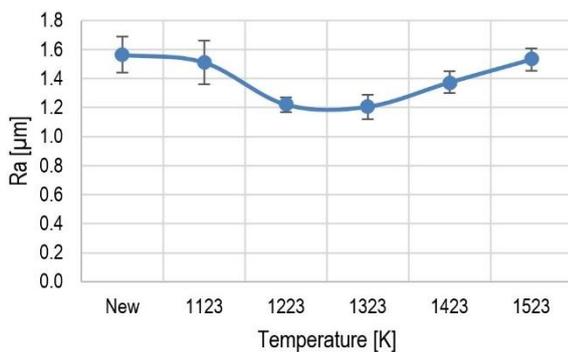
Fig. 3. Impact of heating temperature on roughness profile changes –  $R_a$

The impact of increasing temperature causes the  $R_a$  and  $R_z$  roughness parameters initially decrease up to a temperature of 1223 K, followed by a slight increase up to 1323 K. The increase in  $R_a$  and  $R_z$  parameters is caused by the growing thickness of the heat-resistant coating, which considerably impacts the deterioration of its heat and corrosion resistance. Furthermore, various  $Al_2O_3$  and NiO oxides are formed on the blade coating surface together with increasing heating temperature. Aluminium oxide protects the coating surface against further oxidation. It has a morphologically heterogeneous structure and a tendency to uneven growth and exfoliation. Fluctuations in the parameters determining surface roughness are related to the processes of thermal softening, oxidation and microstructural changes. The presence of areas highly rich in carbon and sulphur was found on the coating surface. Their occurrence is directly associated with aviation fuel components. The most undesirable aviation fuel component is sulphur, which can occur in free or bound form of sulphides, disulfides and hydrogen sulphide. In the course of tests, the authors found that the total percentage share of oxides on coating surfaces initially grows, followed by a decrease at the highest heating temperature. The percentage weight share of the elements making up the coating is modified due to heating. A significant content difference can be seen, primarily in relation to the following elements: W, Mo, Ni and Al.

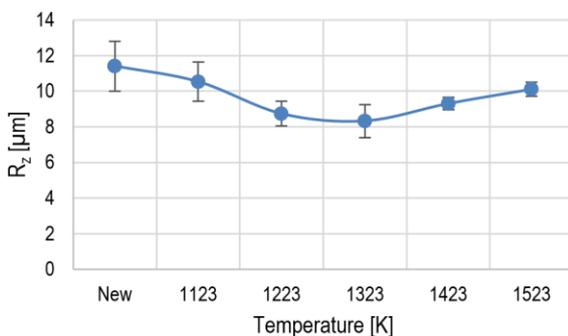
Fig. 4. Impact of heating temperature on roughness profile changes –  $R_z$

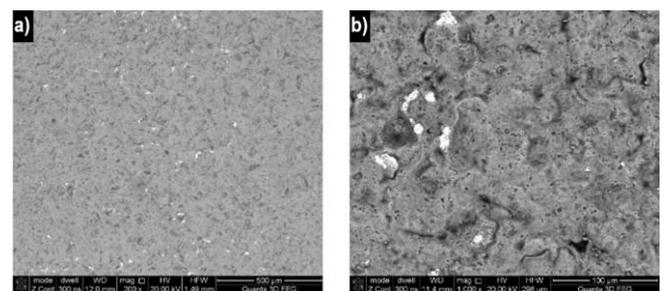
Fig. 5. Blade surface morphology - new, not heated: a) BSE-TOPO; b) BSE

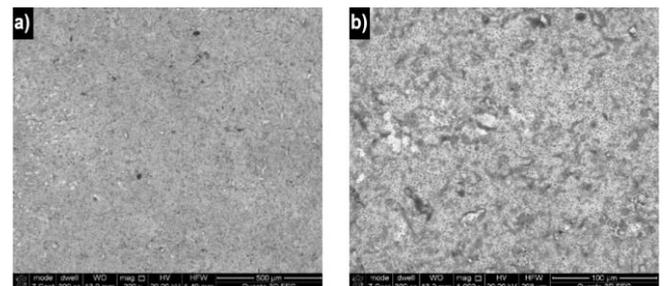
Fig. 6. Blade surface morphology at 1123 K: a) BSE-TOPO; b) BSE

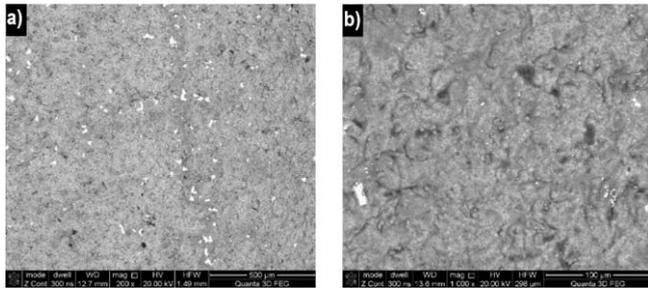
Fig. 7. Blade surface morphology at 1223 K: a) BSE-TOPO; b) BSE

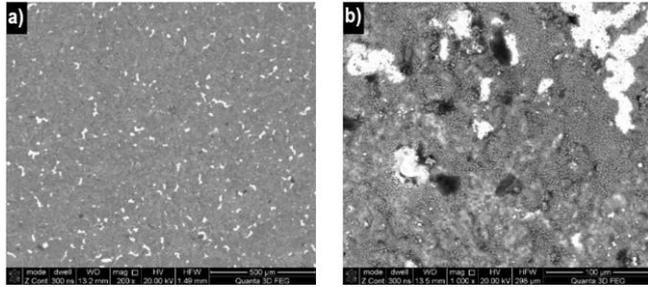
Fig. 8. Blade surface morphology at 1323 K: a) BSE-TOPO; b) BSE

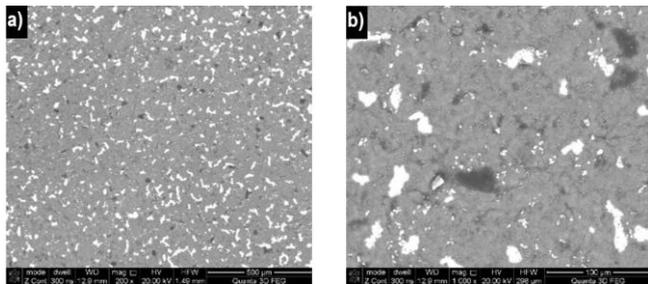
Fig. 9. Blade surface morphology at 1423 K: a) BSE-TOPO; b) BSE

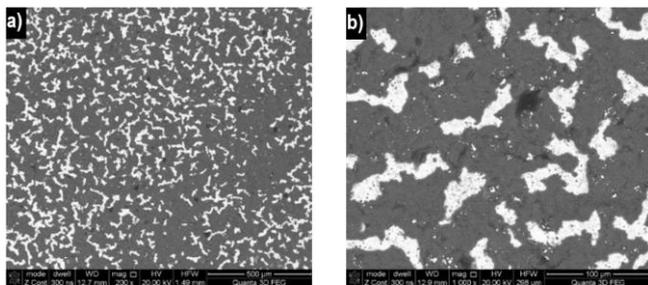
Fig. 10. Blade surface morphology at 1523 K: a) BSE-TOPO and b) BSE

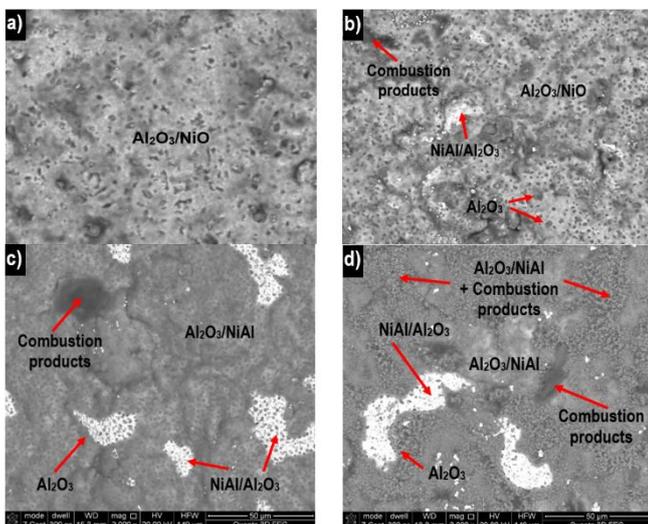
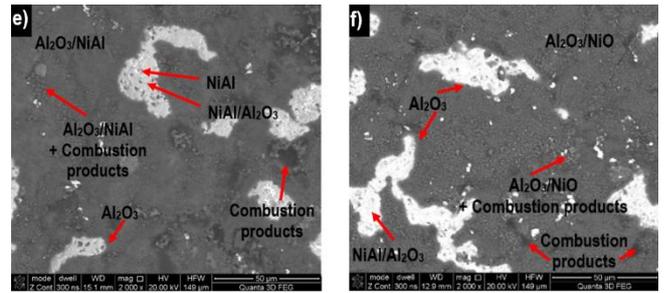
Fig. 11. Blade surface morphology: a) new; b) 1123 K; c) 1223 K; d) 1323 K; e) 1423 K; f) 1523 K

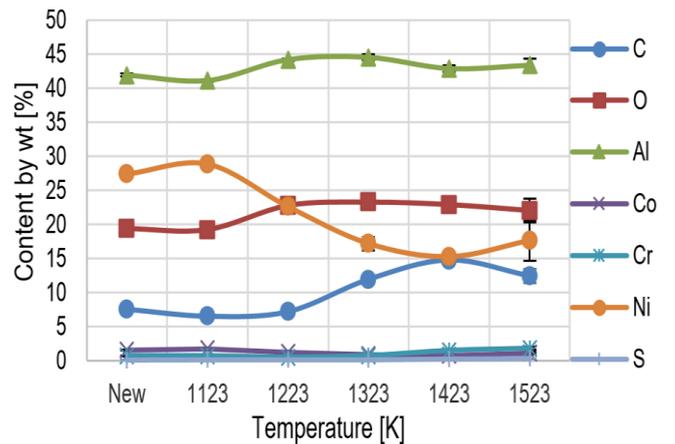
Fig. 12. Percentage share by weight of elements on the surface of tested blades – (SEM/EDS)

Recorded structural changes ongoing on the surface of the analysed blades under the impact of temperature lead to very significant difference in the chemical and phase composition. It was found, among others, that a blade heating temperature increase results in considerable changes in the content of individual surface elements, primarily oxygen, chromium, nickel and carbon (Fig. 12-13). The observed changes are confirmed by independent EDS (Energy Dispersive Spectroscopy) and element mapping testing.

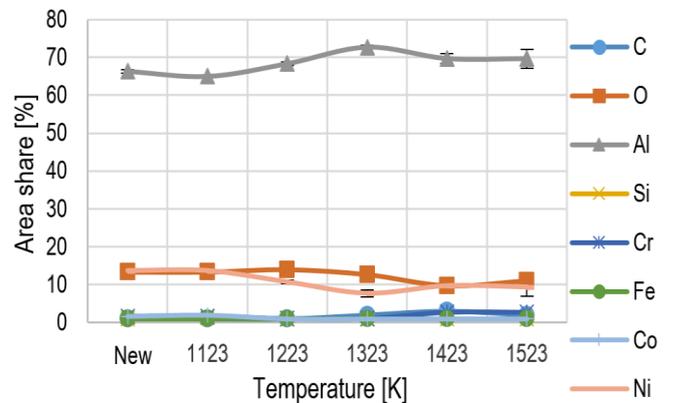
Fig. 13. Percentage share of elements on the surface of tested blades – element mapping method

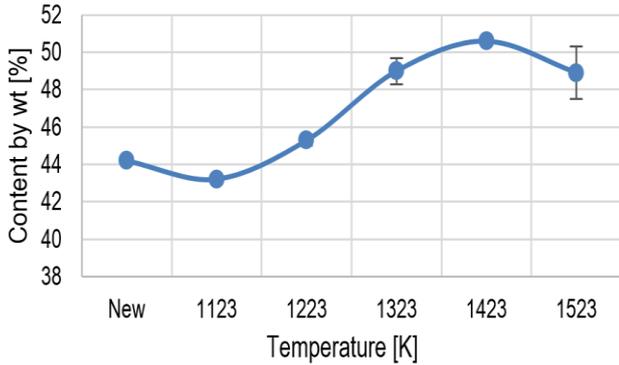
Fig. 14. Total percentage share of oxides measured on the surfaces of tested blades

Changes in the content of individual elements also translate to phase changes. They are particularly emphasized if we analyse the impact of temperature on the percentage content share of oxides on the surface of tested blades (Fig. 14). Based on the obtained data, it can be clearly seen that with increasing temperature, the mass oxide share reaches its maximum for a blade heated at 1423 K. In this case, the total oxide share exceeds 50% of the weight content. Furthermore, the recorded changes in oxide share directly translate to changes in their type. The impact of temperature on nickel oxide share changes is particularly noticeable in this case (Fig. 15). NiO content share changes impacted by temperature are primarily associated with the creation of the Al<sub>2</sub>O<sub>3</sub> scale on the surface of the analysed blades.

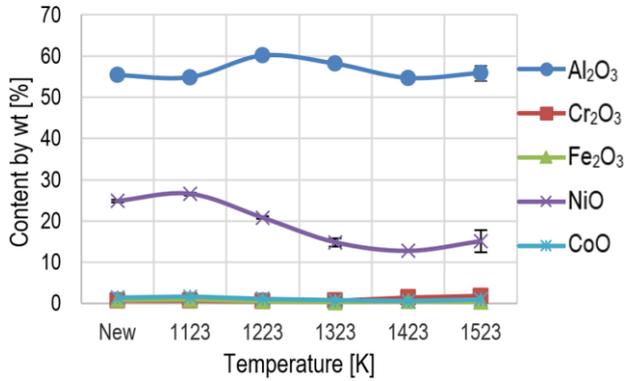
Fig. 15. Percentage share of individual oxides measured on the surfaces of tested blades

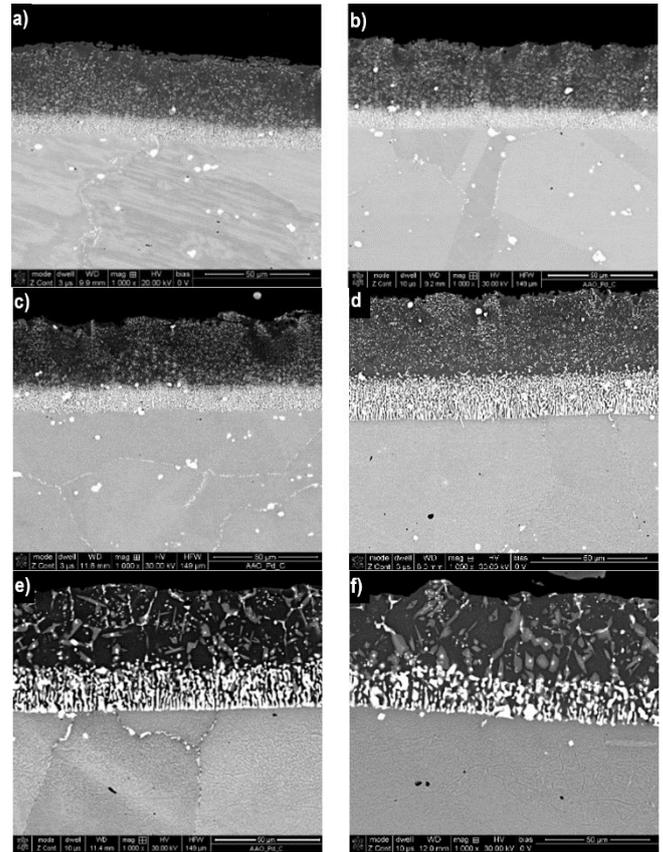
Fig. 16. Blade coating microstructures by heating temperature: a) new; b) 1123 K; c) 1223 K; d) 1323 K; e) 1423 K; f) 1523 K

Thickness measurements were conducted using computer software for processing and analysing images from a Quanta 3D FEG microscope. Coating thickness was measured at characteristic blade locations, i.e., its edge of attack, trough surface and blade ridge – both inside and near the blade vane profile trailing edge. This provided an averaged aluminium thickness layer for each recorded (analysed) image (Fig. 16). Measured coating thickness values of a new blade (not heated) and a blade heated at different temperatures are shown in Fig. 17.

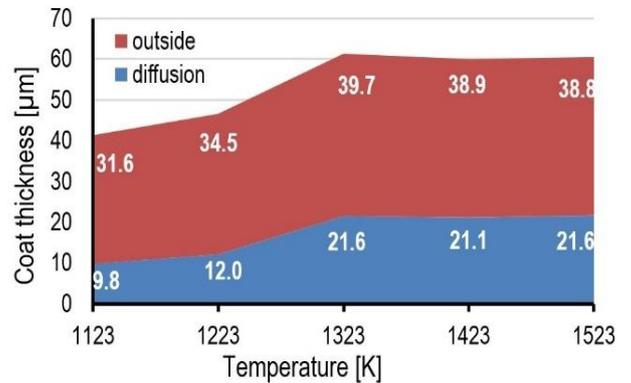
Fig. 17. Changes in the thickness of the external and diffusion coating exposed to different temperatures

- Increase in coating thickness due to exposure to high temperatures is related to thermal expansion, phase changes and its oxidation. "Coating swelling" translates into a strong deterioration of its protective properties (in operating conditions, all destructive processes are intensified). Microstructural changes of the coating affecting the colour of its surface.

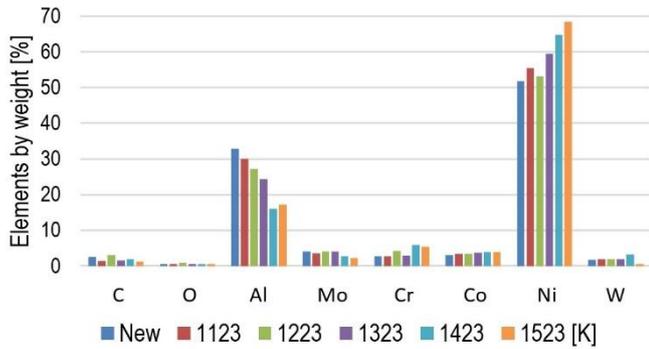
Fig. 18. Chemical composition of the external coating part of a new blade and heated blades

The tests demonstrated that increased blade heating temperature leads to significant changes in the content of individual coating elements, nickel, chromium and aluminium in particular. Cumulative test results for a new blade and blades heated at 1123 K – 1523 K are shown in graphs (Figs. 18 and 19).

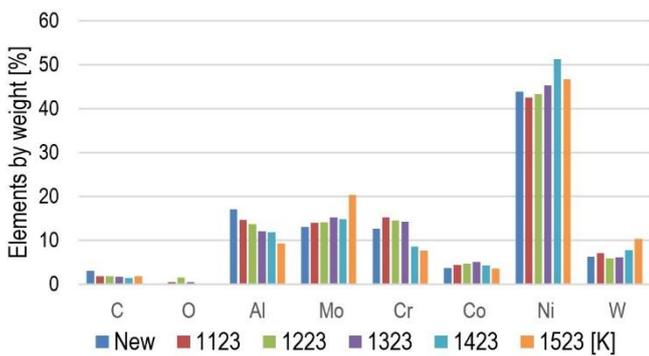
Fig. 19. Chemical composition of the diffusion coating part of a new blade and heated blades

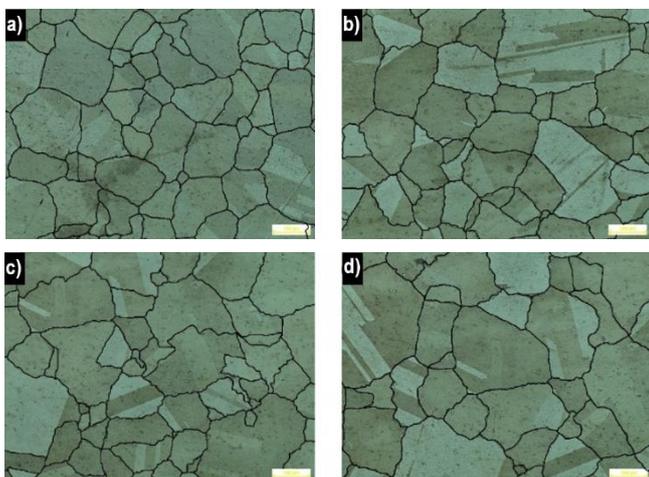
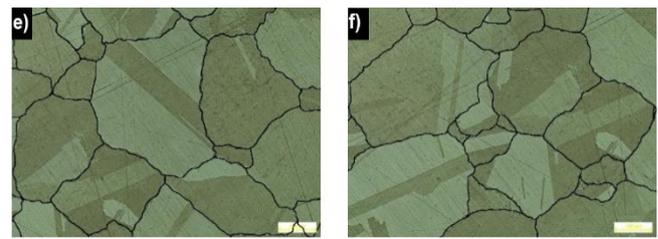
Fig. 20. Blade alloy grain size by heating temperature: a) new; b) 1123 K; c) 1223 K; d) 1323 K; e) 1423 K; f) 1523 K

Metallographic microsections were tested under a Nikon MA-200 optical microscope and a Quanta 3D FEG and XL30 LaB6 scanning (SEM) microscopes by Philips. Using NIS Elements AR material microstructure image analysis software, the authors determined the mean size (area) of the alloy grain and reinforcing phase  $\gamma'$ , expressed as the diameter of a circle with an area equal to the surface area of the measured object ( $Eqdia = \sqrt{4 \cdot Area / \pi}$ ). Images depicting alloy grain size by heating temperature can be seen in Fig. 20, and a change in its average size as a heating function can be seen in the graph in Fig. 21.

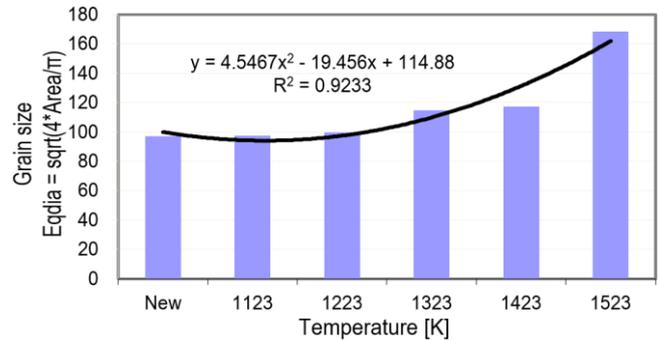
Fig. 21. The dependence of a change in the average blade alloy grain size on heating temperature, expressed by an equivalent diameter of a circle with an area equal to the grain surface area

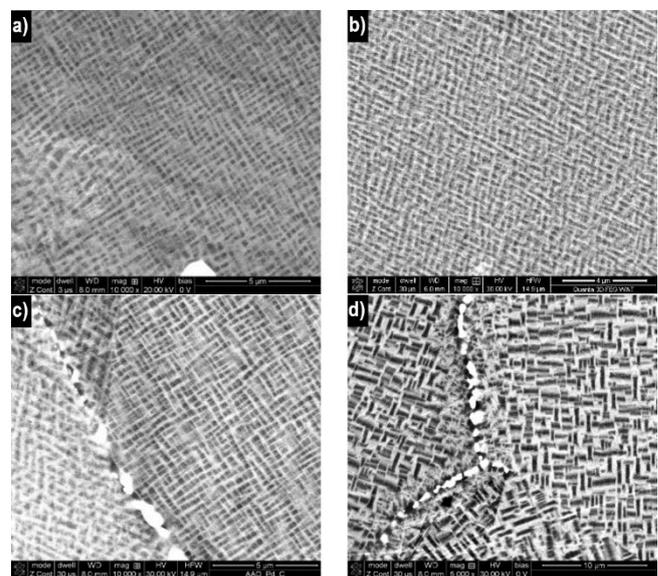
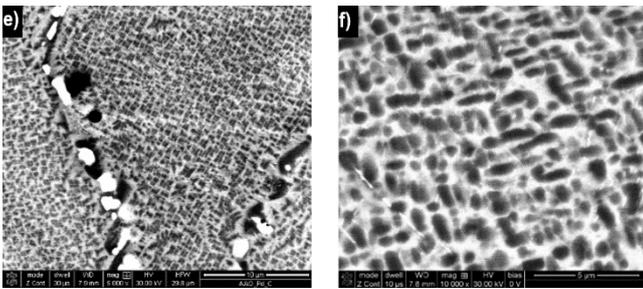
Fig. 22. Blade alloy phase  $\gamma'$  precipitate morphology by heating temperature: a) new; b) 1123 K; c) 1223 K; d) 1323 K; e) 1423 K; f) 1523 K

The presence of carbides, even in a non-heated blade, can be observed in the alloy microstructure. Carbide content increases during heating, especially on grain boundaries. Carbides are stand-alone and in the form of "Chinese writing". A change in the  $\gamma'$  precipitate morphology was also found. The exposure of turbine blade alloy to high temperature also impacted their microstructural change, leading to a modification and distribution of the dispersive  $\gamma'$  phase. Fig. 22 shows sample images of microsections demonstrating the phase  $\gamma'$  precipitate morphology and the presence of stand-alone carbides. Based on analysing the microsections, the authors calculated a percentage content of individual phase  $\gamma'$  size classes in the blade alloy (Fig. 23) and the content of average-sized precipitates of this phase (Fig. 24).

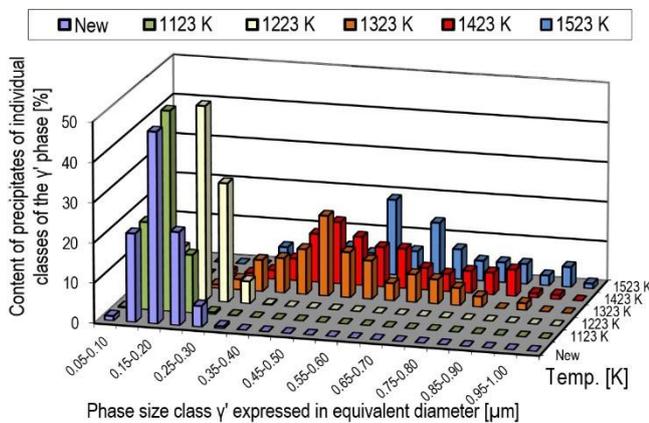
Fig. 23. Percentage precipitate content of individual phase  $\gamma'$  molecule size classes in the alloy

In the course of heating, the reinforcing  $\gamma'$  phase experiences significant changes, and its structure is modified (Fig. 23). A temperature of 1123 K favours the growth of phase  $\gamma'$  particles.

The average size of this phase molecules increases at a temperature of 1323 K (Fig. 23, Fig. 24). While at 1423 K, due to coagulation, the molecules with the largest initial dimensions increase (Fig. 23, Fig. 24).

It was found that temperature increase entails a reduction in the number of molecules with the largest dimensions relative to material microstructure changes in a new blade and a blade heated at 1123 K (Fig. 23). An increasing distance between  $\gamma'$  phase molecules is simultaneously seen. The observed growth, merging and wavy shape of the  $\gamma'$  phase particles are characteristic of an

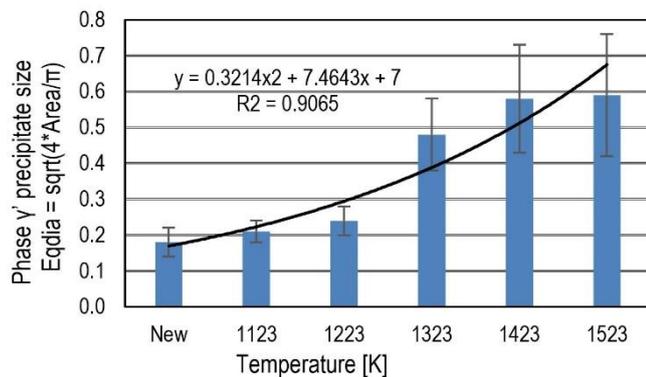
Fig. 24. Dependence of the average phase  $\gamma'$  precipitation in the alloy

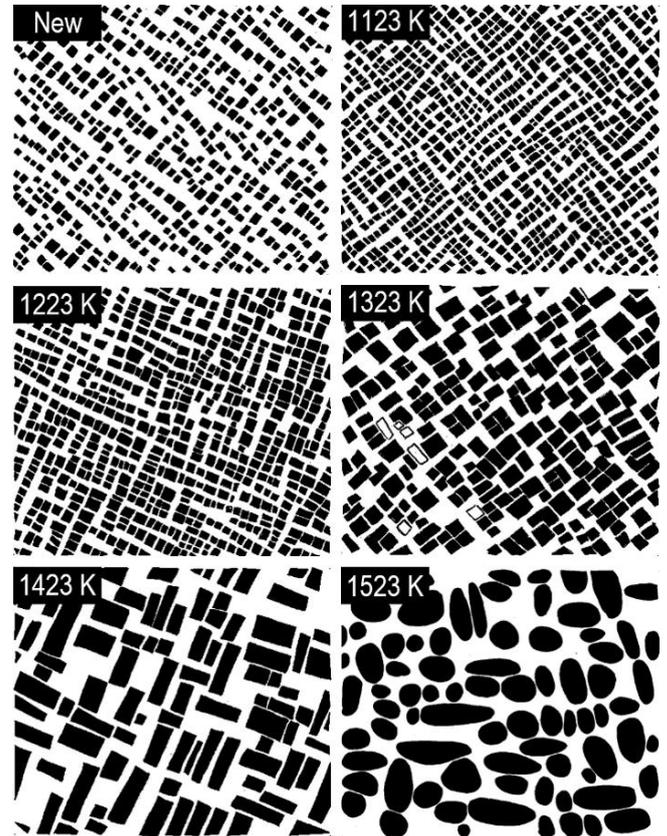
Fig. 25. Phase  $\gamma'$  precipitate microstructure of a new blade and heated blades (20000x zoom) – with visible coagulation, change of shape from cubic to irregular and phase precipitate undulation

overheated alloy and significantly reduce its heat resistance. Assuming the change in the phase  $\gamma'$  precipitate structure (Fig. 25) as a material criterion that enables further operation of the material, one can determine the suitability threshold for their further operation. According to the test results, after the temperature exceeds 1223 K and after an even relatively short exposure time, an intensive growth of the  $\gamma'$  precipitate occurs due to the bonding of fine-grained cubic phase  $\gamma'$  molecules into lamellas. This leads to the loss of cubic shape stability and the formation of irregular and undulated lamellas (Fig. 25).
